**Flood Control Project Maintenance  
Levee Inspections**

## Maintenance Issue Types Only, Levee Inspection Report By Mile - Spring 2019

### Sutter Maintenance Yard Maintenance Area 0016

Waterway	Bank	Unit Miles	Inspection Start/End	Inspector
Unit No. 01 Feather River	Right	4.06	04/04/2019 04/04/2019	Sterling York

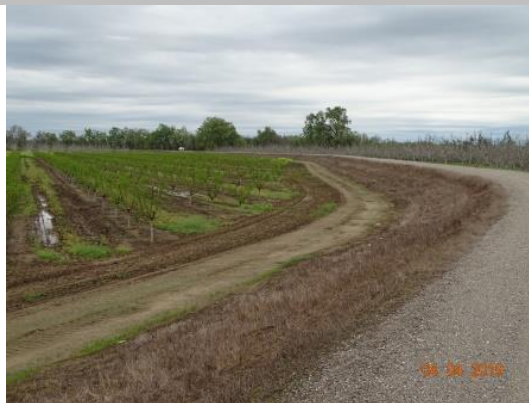
Photo 1 of 1 : SP\_2019\_MA0016\_302\_7\_20190409\_00011.jpg

LM Start	0.01	Rating **	A	Issue No.	7
LM End	4.06	Issue Type +	Ma	Location *	LS
Category	Earthen Levee			GPS Latitude/Longitude	
				Start	End
Item	Vegetation			39.255931 °	39.310941 °
				-121.636394 °	-121.637634 °
DWR ID	DWR_MA0016_01_s_2019_7				
Comment Code					
V1 : Control annual grass and weeds on the levee slopes and easements.					
Inspector Comment					
The annual vegetation is well maintained, Spring 2019.

View looking upstream landside at the well maintained vegetation, Spring 2019.

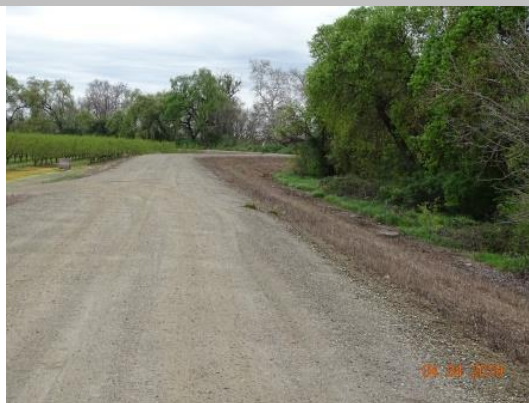
Photo 1 of 1 : SP\_2019\_MA0016\_302\_8\_20190409\_00012.jpg

LM Start	0.01	Rating **	A	Issue No.	8
LM End	4.06	Issue Type +	Ma	Location *	WS
Category	Earthen Levee			GPS Latitude/Longitude	
				Start	End
Item	Vegetation			39.255931 °	39.310941 °
				-121.636394 °	-121.637634 °
DWR ID	DWR_MA0016_01_s_2019_8				
Comment Code					
V1 : Control annual grass and weeds on the levee slopes and easements.					
Inspector Comment					
The annual vegetation is well maintained, Spring 2019.

View looking upstream waterside at the well maintained vegetation, Spring 2019.

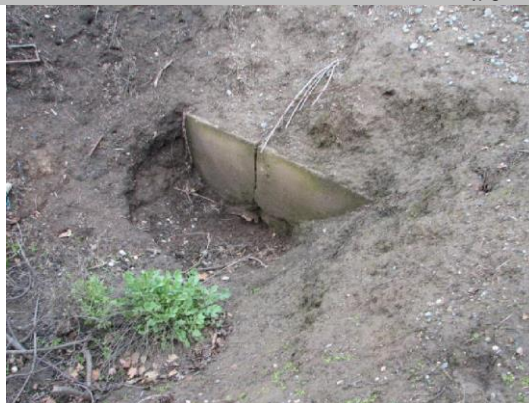
Photo 1 of 2 : UCIP\_SP\_2019\_54027\_65782.jpg

FS\_ID:54027  
DS\_ID:17125  
EP\_NO: N/A  
Repair Type: Non-Urgent  
Crossing Status: Found  
UCIP Comments: 05/22/2019 (O. Magana - DWR UCIP)05/22/2017  
LS inlet buried. WS access being blocked off by over grown vegetation. Pipe has been selected for internal cleaning and inspection as part of the DMP project. (DWR Sutter Yard - AFreitag)12/01/2016  
LS inlet completely buried. (DWR Sutter Yard- AFreitag)05/26/2016  
LS inlet was completely buried.06/08/2015 Concrete headwall is still cracked and inlet is buried. It was said to be replaced with the SBFCA project but the project skipped over in this area.12/29/2014 Same as last inspection.05/19/2014 Same as last inspection.11/06/2013 Same as last inspection.05/14/2013 SBFCA project recommends replacing in accordance with title 23. Same as last inspection.12/11/2012 Concrete headwall on LS toe is cracked through middle and pipe is buried in soil. pipe appears corroded. (DWR UCIP - W. Wylie)

Headwall at LS toe is cracked and the inlet is buried in soil.

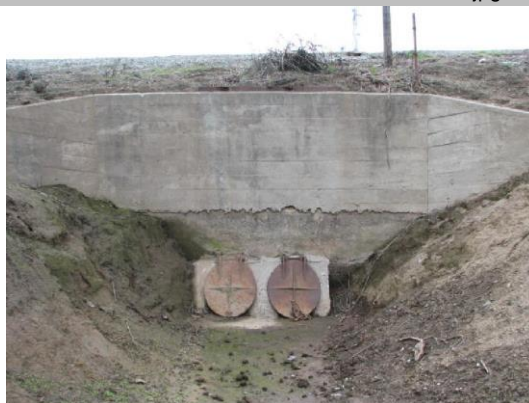
Photo 2 of 2 : UCIP\_SP\_2019\_54027\_65781.jpg

Headwall on WS toe with flap gates.

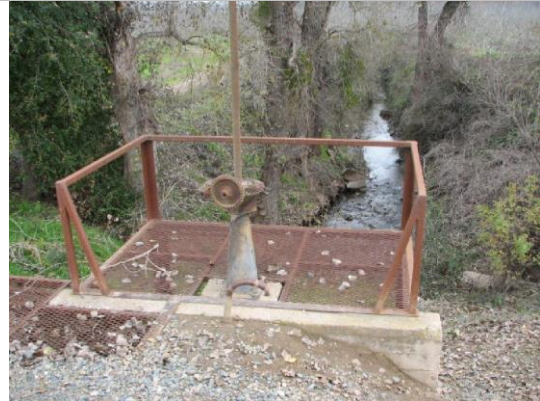
Photo 1 of 3 : UCIP\_SP\_2019\_54030\_65785.jpg

FS\_ID:54030  
DS\_ID:17123  
EP\_NO: N/A  
Repair Type: No Action Needed  
Crossing Status: Found  
UCIP Comments: 05/22/2019 (O. Magana - DWR UCIP)05/22/2017 Crossing appears to be in good condition. (DWR Sutter Yard - AFreitag)12/01/2016 Crossing appears to be in good condition. (DWR Sutter Yard- AFreitag)05/26/2016 Crossing appears to be in good condition.06/08/2015 Pipe appears to be in good condition. No noticeable issues to report. Pipe was listed to be replaced with the SBFCA project but the project did not take place in this area.12/29/2014 Same as last inspection.05/19/2014 Same as last inspection.11/06/2013 Same as last inspection.05/14/2013 Slide gate opened allowing water to flow through, debris problem has been cleared and the gates seem to be functioning properly. SBFCA project recommends replacing in accordance with title 23.12/11/2012 Lock missing from concrete well access door-this should be resplaced. Some debris blocking preventing flapgate from completely closing. (DWR UCIP - W. Wylie)

Slide gate, concrete well, siphon breaker/air vent and open channel on WS of levee.

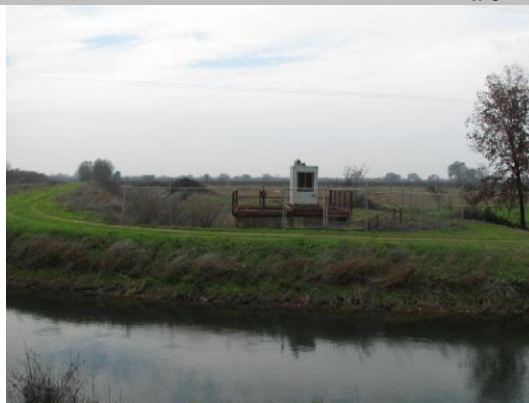
Photo 2 of 3 : UCIP\_SP\_2019\_54030\_65784.jpg

Pumping plant and slide gate on LS across canal. (no access from levee).

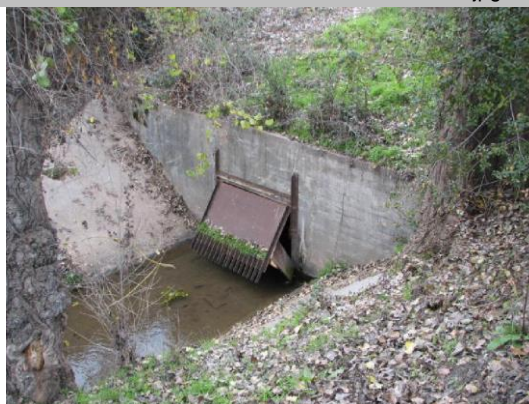
Photo 3 of 3 : UCIP\_SP\_2019\_54030\_65783.jpg

Concrete headwall and flap gate on WS toe.
